OPTIMISATIONS BROUGHT ON RIBAMBELLE & RIBAMBELLE XL

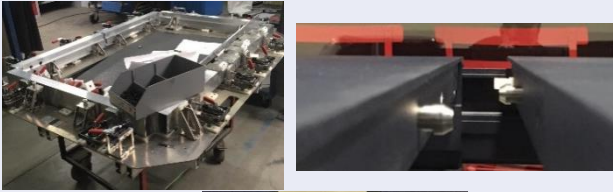
Horizontal gap between table top and extensions	<ul style="list-style-type: none"> - Revue of the pegging tools - Creation of tools helping the control - Modification of the indexing finger - Accepted tolerance of 1 mm max
